# Manhole Inspection Summary

Manhole # S55E\_\_010MH

Insp Date: **7/21/08 10:44 AM**

**Location** Address: **3509 leverton ave**

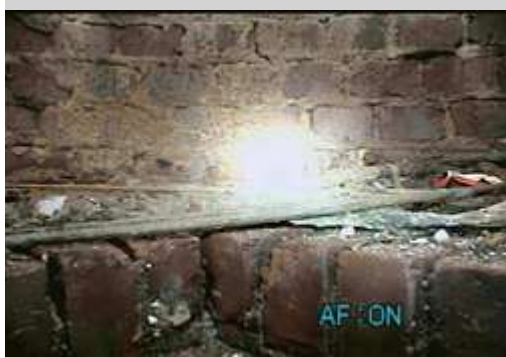
Defect 3

Condition: ☐ Sound ☐ Cracked ☐ Root Intrusion ☐ Deteriorated ☐ Leaks ☒ **Debris**

bench debris

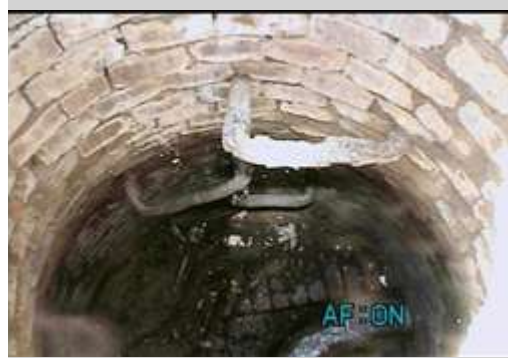
Defect 2

Count: **3** Missing: **0** ☒ **Corroded**

corroded steps

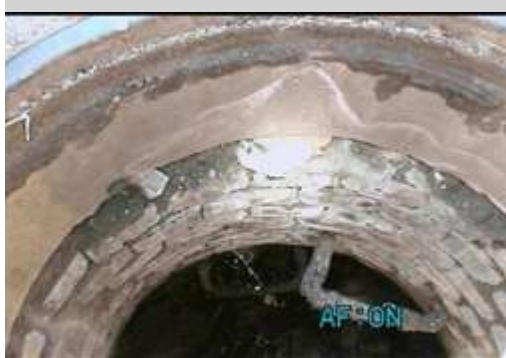
Defect 1

Offset: **2** (in.)

Condition: ☐ Sound ☐ Cracked ☐ Root Intrusion ☒ **Loose Brick** ☒ **Deteriorated**

corbel\_loose bricks frame offset

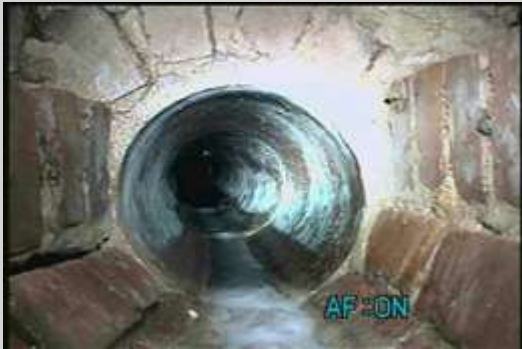
12 O'Clock Outflow

8 in. Circular Gravity Sewer  
Pipe Out @ 12 O'Clock

Invert Depth: 7.40 (ft.) Flow Characteristics: **Fast**

Deposits: ☒ None ☐ Mud ☐ Sludge ☐ Debris ☐ Grease

Infiltration: **None** Pipe Seal Cond: **Unknown**

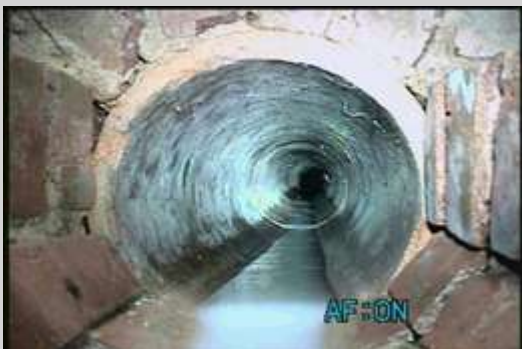
9 O'Clock Inflow

8 in. Circular Gravity Sewer  
Pipe In @ 9 O'Clock

Invert Depth: 7.30 (ft.) Flow Characteristics: **Fast**

Deposits: ☒ None ☐ Mud ☐ Sludge ☐ Debris ☐ Grease

Infiltration: **None** Pipe Seal Cond: **Unknown**
